URGENT RECALL NOTICE

FMI 15038

Subject: Product Safety Issues

Affected Products: OEC® ENTrak 2500 Plus, OEC® IT 3500 Plus and OEC® 9800 C-Arm Navigation Systems

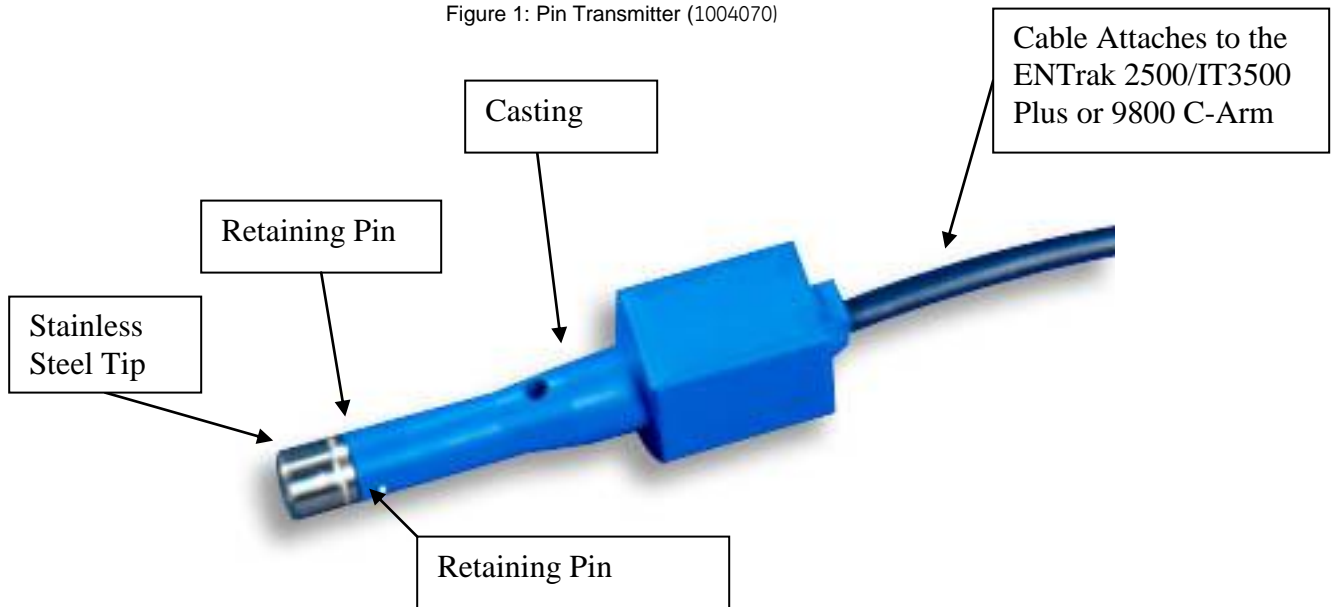
Figure 1: Pin Transmitter (1004070)

The housing of the Pin transmitter consists of two main parts: the casting (plastic) and the stainless steel tip that attaches the housing to the clamp/pin that is affixed to the patient (See Figure 1). The design is intended to have a small pin through each sidewall of the casting to secure the stainless steel tip with two pins. In a few cases, we have seen that the stainless steel tip of the Pin Transmitter has disconnected from the casting because only one pin of the transmitter was secured. In these cases, there is a potential for this small, unattached retaining pin to fall into the surgical field.

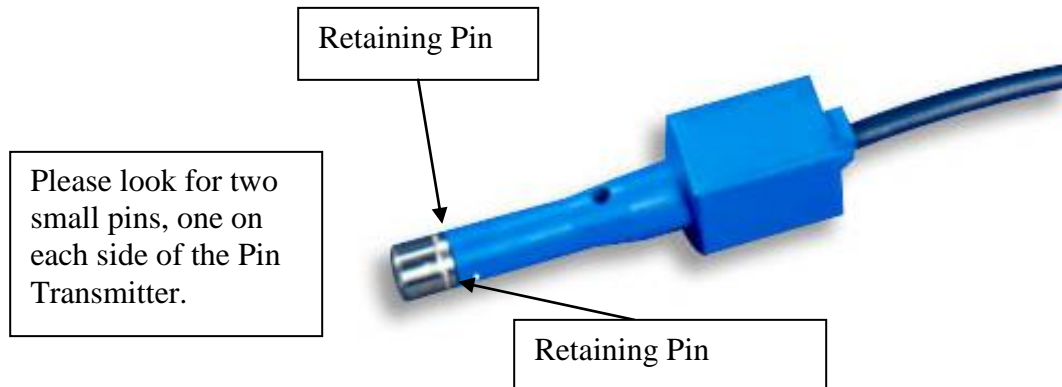
Figure 2: Pin Transmitter (1004070)

Please perform a visual inspection of your GE Healthcare Surgical Navigation Pin Transmitter (PN: 1004070) to make sure that your Pin Transmitter is pinned on both sides of the transmitter (See Figure 2) and follow the instructions below:

- 1) Please discontinue the use of the Pin Transmitter and contact GE Healthcare by completing the attached form and FAX it to GE Healthcare Regulatory Affairs to arrange for a part replacement of the Pin Transmitter.
- 2) Please convey this information to your OR management along with all users of the ENTrak 2500 Plus, InstaTrak 3500 Plus, or 9800 C-Arm Navigation Systems.

If you have an affected Pin Transmitter, we will replace it as soon as possible at no cost to you. A GE Surgery Field Service Engineer will be contacting you to arrange for a part replacement which will enable you to continue using your ENTrak 2500 Plus, IT 3500 Plus and 9800 C-Arm Navigation Systems.
