GE Healthcare

URGENT RECALL NOTICE

Subject: Product Safety Issues

Affected Products: OEC® 9900 Elite, OEC®, 9900 Elite^{MD} Motorized C-arm System, OEC® 9900 Elite^{NAV}

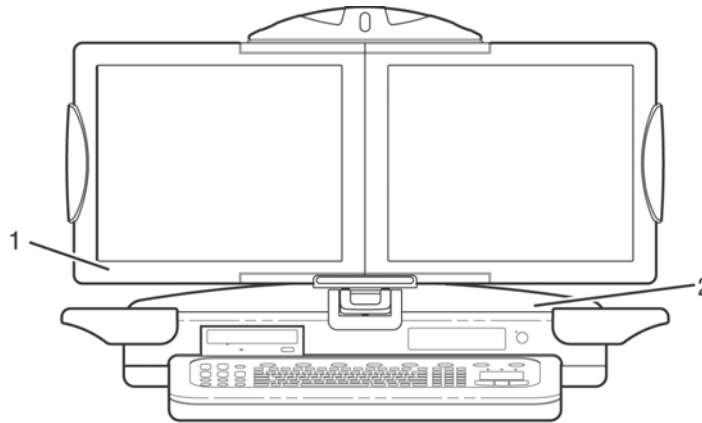
SUGGESTED PLACEMENT OF STICKER ON SYSTEM

2. System Lock Up:

GEHC OEC has become aware of a potential problem with the above-indicated products where the C-arm may lock-up. Specifically, during system usage, the system may fail to function (produce live x-rays), and the collimators may close. In addition, the system display may indicate that the system is active (such as sound and/or light displays) when, in fact, the system is not producing live x-rays. The left monitor of the system will not update (no live fluoroscopy). There will be no radiation emission occurring despite the audible and visual indicators. If it is suspected that the system has emitted an uncommanded radiation exposure the user should contact GEHC to have the exposure logs reviewed to confirm if an exposure was made.

Should your OEC System experience a Lock-up, restarting (rebooting) the system should restore system functionality. The restarting (rebooting) sequence for the 9900 Elite System takes approximately 3 minutes to restore functionality. **Images saved prior to the system locking up will be restored and are retrievable. Images not saved prior to the system failure will not be restored.**

Enclosed is a sheet of supplemental stickers, including instructions for attachment, that demonstrates the restart steps. These stickers should be promptly attached to your system(s) as indicated below (suggest placement in location #2). These instructions are also located in the Operators Guide.

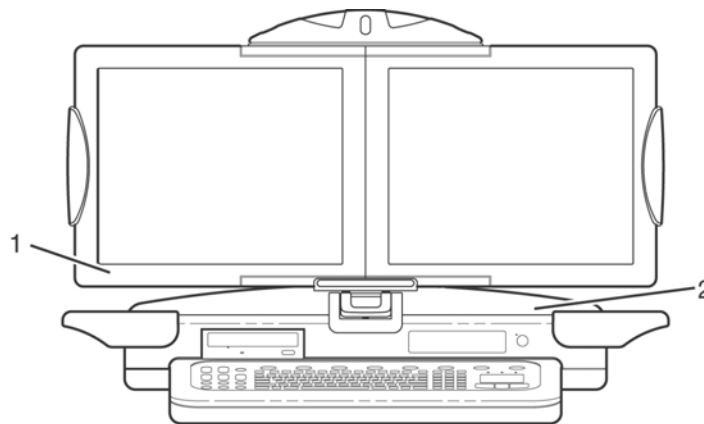
SUGGESTED PLACEMENT OF STICKER ON SYSTEM

3. Incorrect Image Display:

When the image directory is accessed and thumbnail images are used to recall patient images, incorrect images may be displayed or there may be an inability to locate images on the system. The actual images, however, are labeled with the correct patient information, and may be located within another patient’s file.

To reduce the occurrence of this issue The GEHC OEC service team will be contacting you to upgrade your 9900 system’s software to 6.15.3. Additional solutions to eliminate this issue are under investigation by GEHC OEC. To reduce the occurrence of this issue users should follow the correct power down procedure. The power down procedure is described in the Operators Guide and on the supplemental stickers enclosed with this notification.

The supplemental stickers should be installed on your system(s) promptly following the enclosed instructions and as indicated below (suggest placement in location #2).

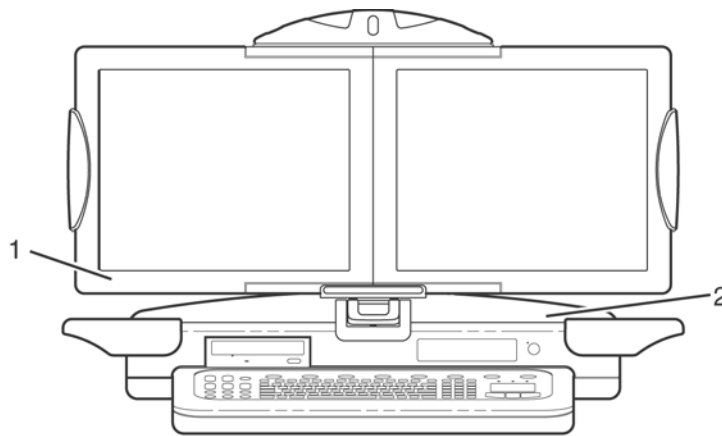
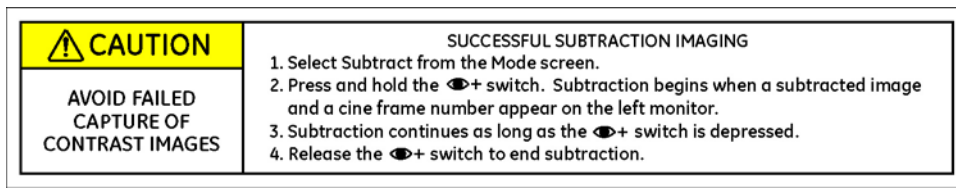
SUGGESTED PLACEMENT OF STICKER ON SYSTEM

5. Subtracted Image Display:

During subtraction a different static image may appear under the real time image.

When acquiring the pre-injection image at the beginning of a subtraction run, the user must allow the system to enter subtraction mode before ending the exposure. A user can confirm that they have entered subtraction mode by the appearance of a subtracted image and the cine frame number on the display screen on the left monitor. If the user does not see the frame number and the subtracted image on the screen the image should be re-acquired prior to continuing with the study. Currently, the only available option, should this situation occur, is to reacquire the image if it serves the best interest of the patient.

Supportive labels containing the above information have been included with this notification. These labels should be placed on your systems following the instructions included with the labels and as indicated below (suggest placement in location #1).

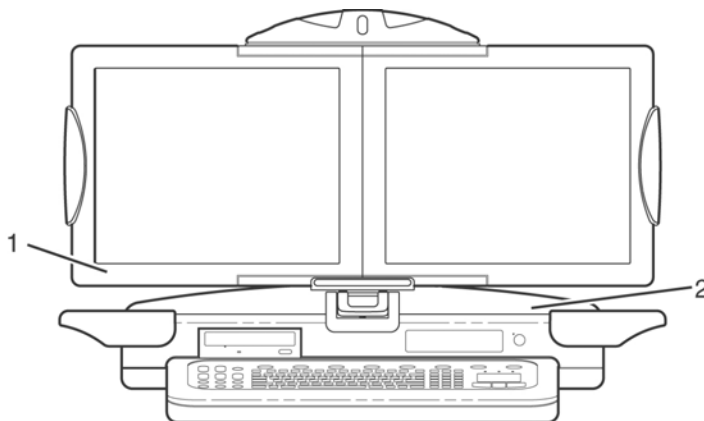
SUGGESTED PLACEMENT OF STICKER ON SYSTEM

7. System does not boot:

OEC 9900 Elite, OEC 9900 Elite ^{NAV} may stall during its boot cycle causing a delay in usage. The most common symptom of an incomplete boot cycle is when the workstation progress bars stall at $\frac{3}{4}$ of completion. The vacuum fluorescent display on the C-arm will stop on 5 arrows. If this condition persists for longer than a minute, the system is stalled.

Rebooting the system should clear the issue and restore system functionality. When rebooting the system for this issue, before reapplying power, it is important to place the power switch in the OFF position and wait **10 seconds**. Should the system fail to reboot a second attempt at rebooting may be required. These instructions are also located in the Operators Guide.

Enclosed is a sheet of supplemental stickers, including instructions for attachment, that demonstrates the restart steps. These stickers should be promptly attached to your system(s) as indicated above (suggest placement in location #2).
