GE Healthcare

URGENT RECALL NOTICE

Subject: Product Safety Issues

Affected Products: FlexiView 8800 Mobile C-Arm, OEC® UroView 2800, OEC® 9800, OEC® FluoroTrak 9800 Plus, OEC® 9800 Plus, OEC® 9800*MD* Motorized C-arm System, and OEC® Miniview 6800

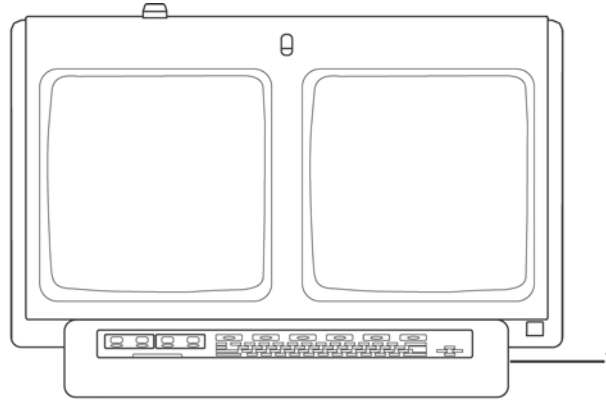
SUGGESTED PLACEMENT OF STICKER ON SYSTEM

GEHC OEC has become aware of a potential problem with the above-indicated products where the C-arm may lock-up. Specifically, during system usage, the system may fail to function (produce live x-rays), and the collimators may close. In addition, the system display may indicate that the system is active (such as sound and/or light displays) when, in fact, the system is not producing live x-rays. The left monitor of the system will not update (no live fluoroscopy). There will be no radiation emission occurring despite the audible and visual indicators. If it is suspected that the system has emitted an uncommanded radiation exposure the user should contact GEHC to have the exposure logs reviewed to confirm if an exposure was made.

Should your OEC System experience a Lock-up, restarting (rebooting) the system should restore system functionality. The restarting (reboot) procedure for OEC 9800 Plus, OEC Flexiview 8800, and OEC UroView 2800 will take less than 3 minutes. **Images saved prior to the system locking up will be restored and are retrievable. Images not saved prior to the system failure will not be restored.** At this time a corrective solution for the OEC 9800 Plus, OEC Flexiview 8800, and OEC UroView 2800 is under investigation. Your facility will be notified as soon as a solution has been identified.

Instructions for rebooting (restarting) the system are located in the Operators Guide. **In addition enclosed is a sheet of supplemental stickers, including instruction for attachment, which demonstrates the restart steps. These stickers should be promptly attached to your system(s) as indicated below (suggest placement in location #1).**

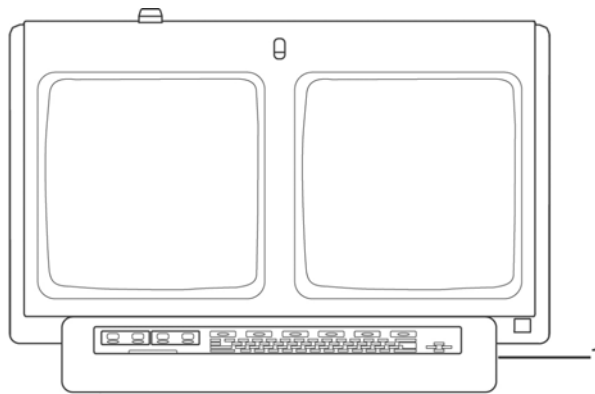
SUGGESTED PLACEMENT OF STICKER ON SYSTEM

When the image directory is accessed and thumbnail images are used to recall patient images, incorrect images may be displayed or there may be an inability to locate images on the system. The actual images, however, are labeled with the correct patient information, and may be located within another patient's file.

To reduce the occurrence of this issue users should follow the correct power down procedure.

The power down procedure is also described in the Operators Guide and on the supplemental stickers enclosed with this notification.

The supplemental stickers should be installed on your system(s) promptly following the enclosed instructions and as indicated below (suggest placement in location #1).

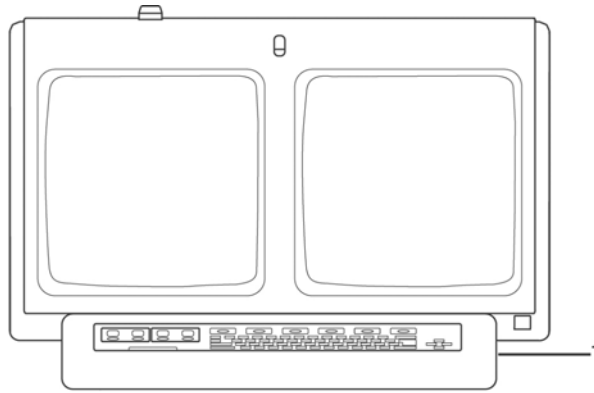
SUGGESTED PLACEMENT OF STICKER ON SYSTEM

FlexiView 8800 Mobile C-Arm, OEC® UroView 2800, OEC® 9800, OEC® FluoroTrak 9800 Plus, OEC® 9800 Plus, OEC® 9800MD Motorized C-arm System, and OEC® Miniview 6800 may stall during its boot cycle causing a delay in usage. If this condition persists for longer than a minute, the system is stalled.

Rebooting the system should clear the issue and restore system functionality. When rebooting the system for this issue, before reapplying power, it is important to place the power switch in the OFF position and wait **10 seconds**. Should the system fail to reboot a second attempt at rebooting may be required. These instructions are located in the Operators Guide.

In addition enclosed is a sheet of supplemental stickers, including instructions for attachment that demonstrates the restart steps. These stickers should be promptly attached to your system(s) as indicated below (suggest placement in location #1).
