## URGENT PRODUCT NOTIFICATION

**Subject:** Product Safety Issues:  
GE OEC 9900 Elite ESP and GE OEC 9900 Elite GSP C-arms.

**Affected Products:** GE OEC 9900 Elite ESP and GE OEC 9900 Elite GSP Systems

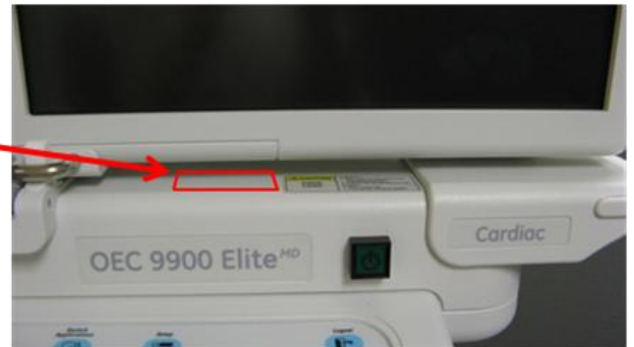
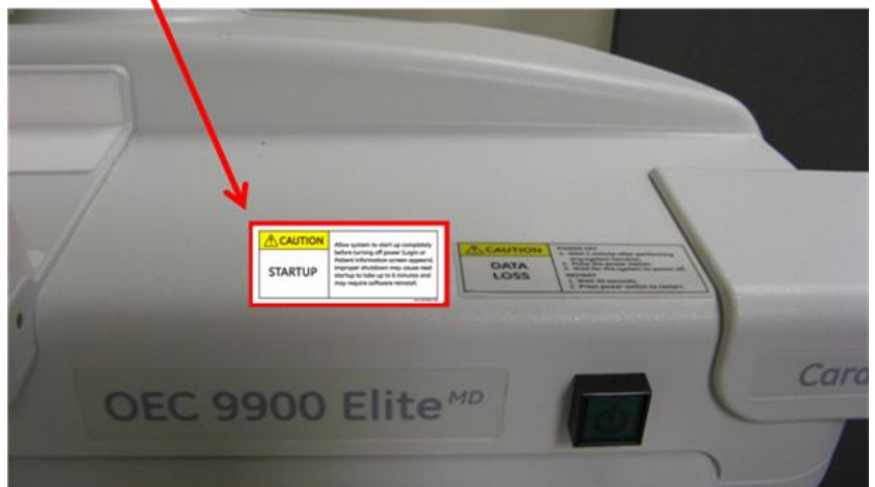
Diagram 1.1:

## Start Up Label Placement

Affix Start Up Label as shown:

**A caution label is included to affix (per diagram 1.1 enclosed) to your system(s) to remind all users of the importance of proper system start up procedures.**
