GE Healthcare

URGENT RECALL NOTICE

Subject: Product Safety Issues

Affected Products: FlexiView 8800 Mobile C-Arm, OEC® UroView 2800, OEC® 9800, OEC® FluoroTrak 9800 Plus, OEC® 9800 Plus, OEC® 9800*MD* Motorized C-arm System, and OEC® Miniview 6800

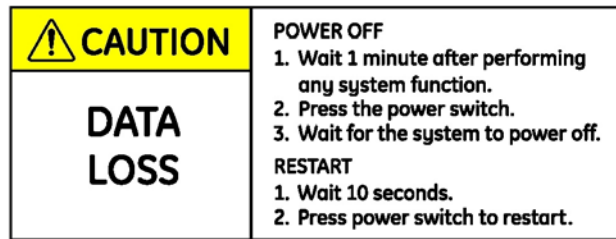
SUGGESTED PLACEMENT OF STICKER ON SYSTEM

FlexiView 8800 Mobile C-Arm, OEC® UroView 2800, OEC® 9800, OEC® FluoroTrak 9800 Plus, OEC® 9800 Plus, OEC® 9800MD Motorized C-arm System, and OEC® Miniview 6800 may stall during its boot cycle causing a delay in usage. If this condition persists for longer than a minute, the system is stalled.

Rebooting the system should clear the issue and restore system functionality. When rebooting the system for this issue, before reapplying power, it is important to place the power switch in the OFF position and wait **10 seconds**. Should the system fail to reboot a second attempt at rebooting may be required. These instructions are located in the Operators Guide.
