# Using VolumeRAD™ to detect scaphoid fracture in single session treatment

Images and case courtesy of:  
Princess of Wales Hospital  
Bridgend, Wales, UK  
Siân Phillips, M.D.

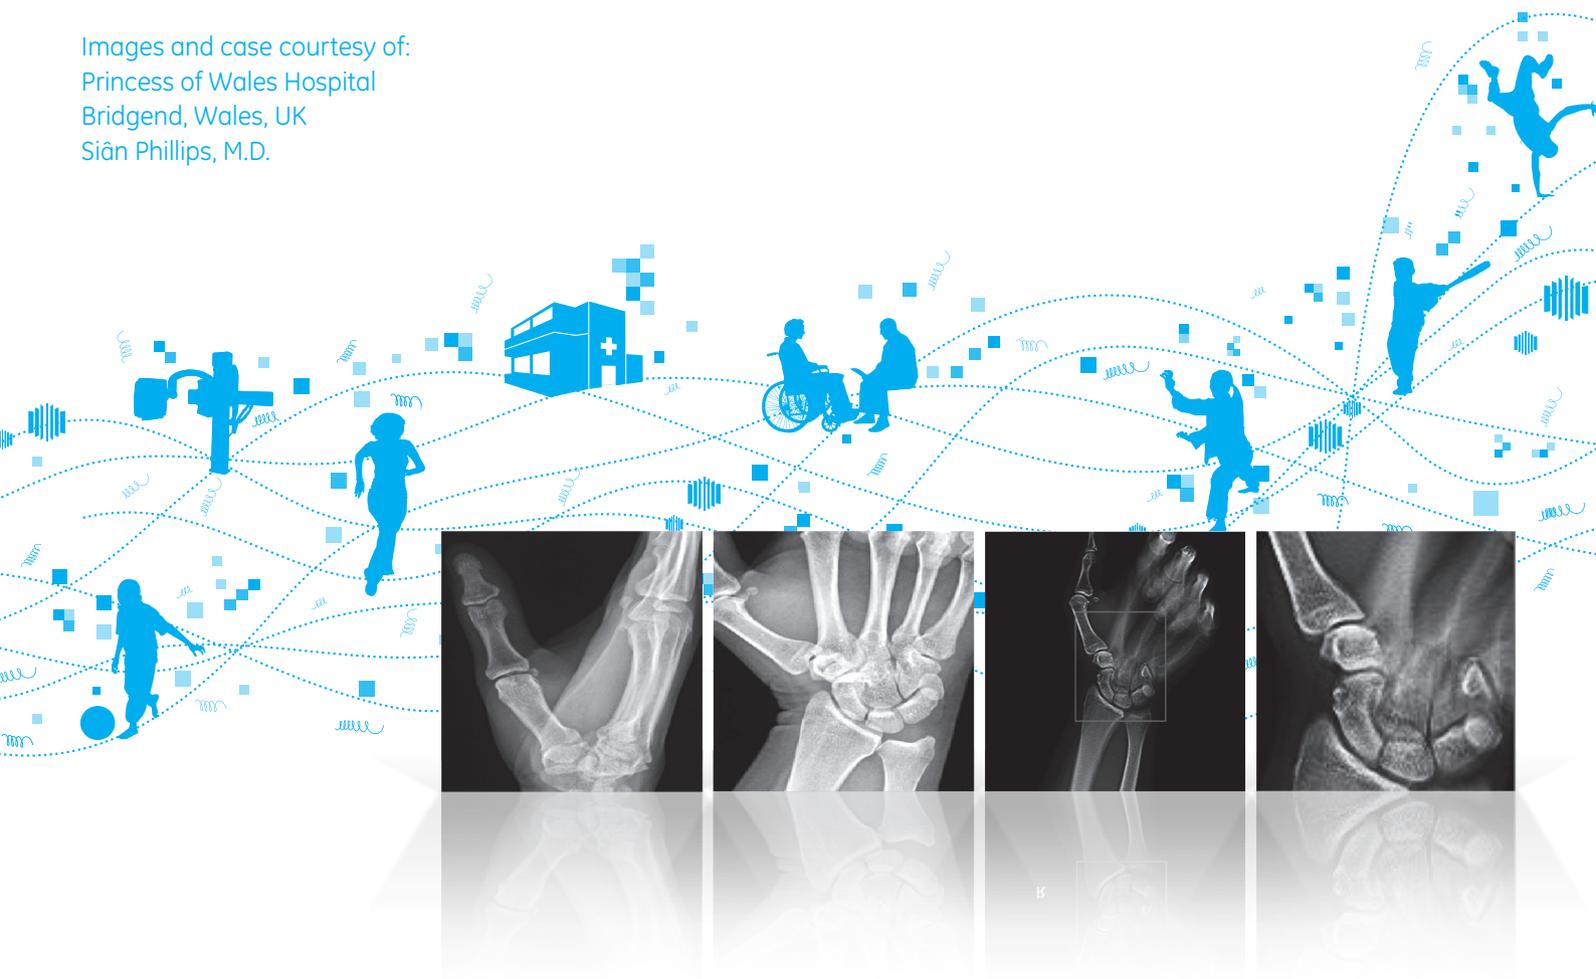
The team first conducted a routine four-view scaphoid exam. No fracture was detected on these exams, which often happens with this type of injury. The team then ordered a VolumeRAD exam, which revealed a cortical fracture.

Dr. Phillips identified the scaphoid fracture through the detail available through the VolumeRAD images. In this instance, VolumeRAD obtained valuable clinical information during this single session of care that the team used to initiate a successful treatment plan.

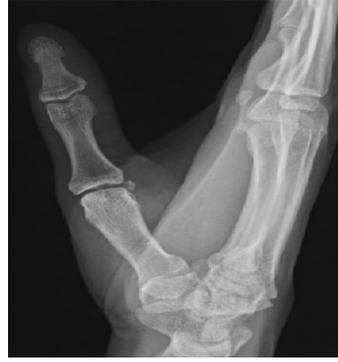
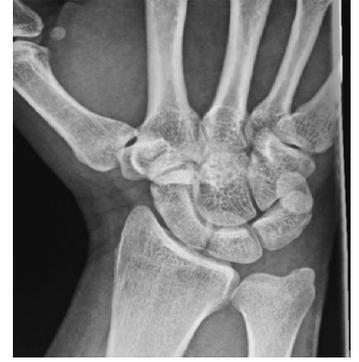
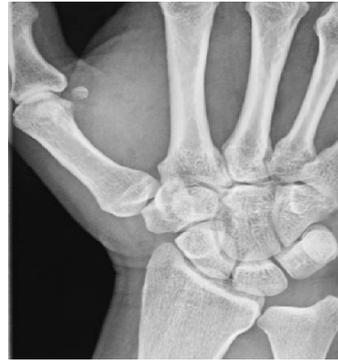
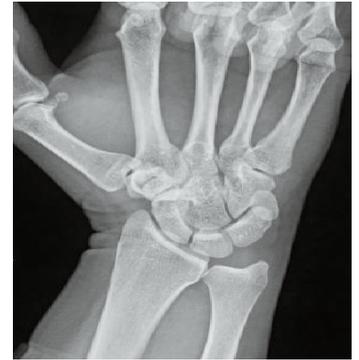
Standard four-view wrist examination:  
no abnormality detected on X-ray

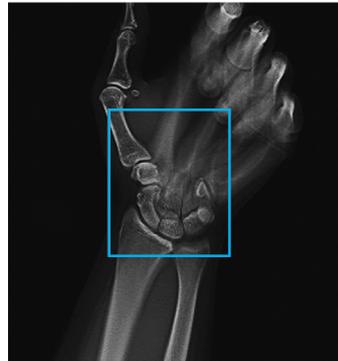
VolumeRAD slices:  
fracture of distal scaphoid pole

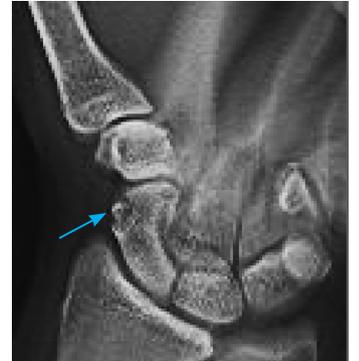
Magnified view  
of VolumeRAD slice
